Manhole Inspection Summary

Manhole # S37GG_009MH

Insp Date: **3/21/07 9:06 AM**

Location Address: **415 OLIVER ST**

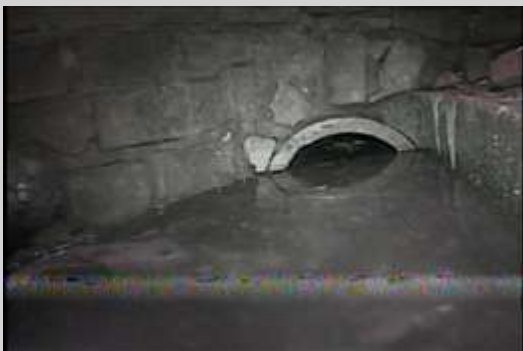
6 in. Circular Gravity Sewer Pipe In @ 3 O'Clock

Pipe Material: **Clay** ☐ Pipe Lined

Invert Depth: **6.09** (ft.) Flow Characteristics: **Slow**

Deposits: ☒ None ☐ **Mud** ☐ Sludge ☐ **Debris** ☐ Grease

Infiltration: **None** Pipe Seal Cond: **Unknown**

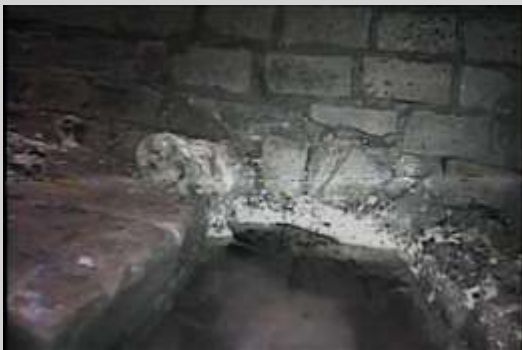
8 in. Circular Gravity Sewer

Pipe Material: **Clay** ☐ Pipe Lined

Infiltration: **None** Pipe Seal Cond: **Unknown**
